UNDERWATER BRIDGE INSPECTION REPORT

STRUCTURE NO. 62082
CR No. 3 (LAKE STREET)
OVER THE
MISSISSIPPI RIVER
DISTRICT 5– HENNEPIN COUNTY

PREPARED FOR THE
MINNESOTA DEPARTMENT OF TRANSPORTATION
BY
COLLINS ENGINEERS, INC.
JOB NO. 5221

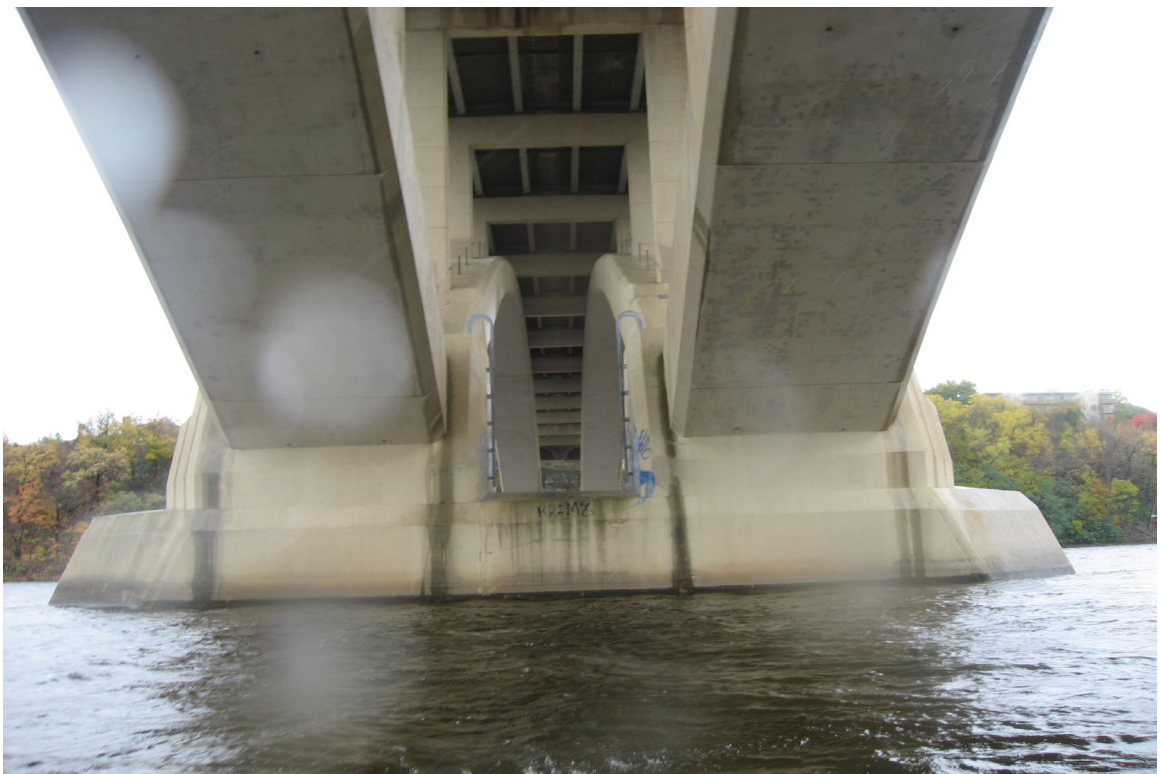
- (A) Scour depression with footing exposure was observed at the upstream nose of Pier 5 and extended for 3/4 of the pier length along both sides of the pier. At the upstream nose, the full 6 feet of the vertical face of the footing was exposed, but no undermining or seal exposure (just top partially exposed) was encountered.

Photograph 2. View of Pier 5, Looking East.

- (A) Monitor the exposure of the footing and partial exposure of the seal at the upstream nose of Pier 5, and if found to be progressing, additional measures may then be warranted.
- (B) Reinspect the submerged substructure units at the normal maximum recommended (NBIS) interval of five (5) years.

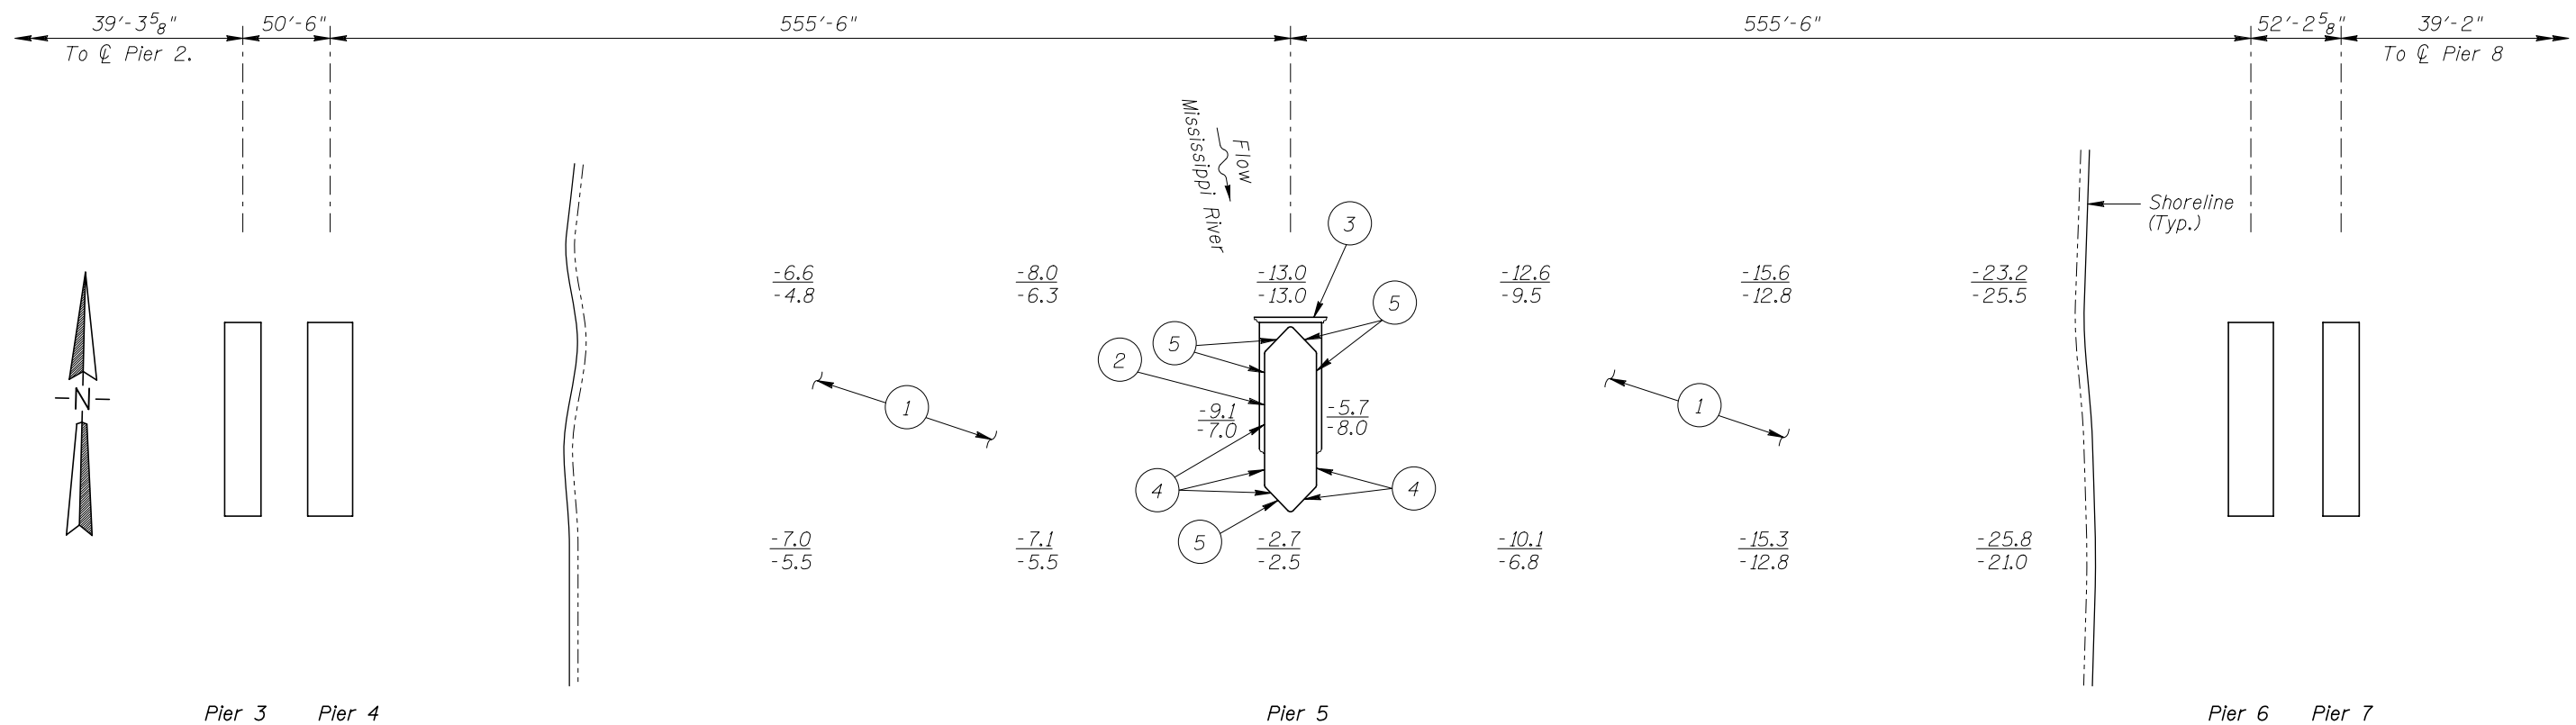
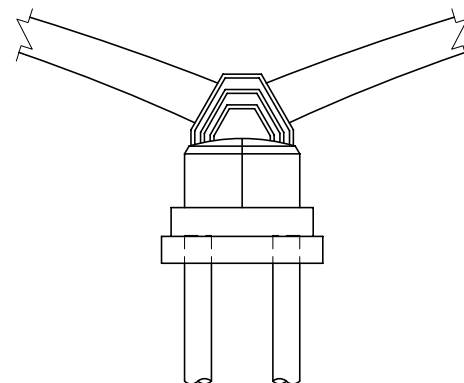
INSPECTION AND SOUNDING PLAN

- The channel bottom material consisted of sand and concrete rubble with up to 6 inches of probe rod penetration. There was also random pieces of scrap steel scattered around the pier on the channel bottom.

- The concrete around the pier was in good and sound condition with a light layer of aquatic growth that extended from the waterline to the channel bottom.

- Footing exposure was observed at the upstream nose of Pier 5 and extended for 3/4 of the pier length way along both sides of the pier. At the upstream nose, the full 6 feet of the vertical face of the footing was exposed (top of seal at channel bottom). The footing and seal exposure is due to localized scour, with an approximate depth of 5 to 7 feet, around the upstream end of the pier.

- A hairline vertical crack was observed that extended from the top of the pier to the channel bottom.
- A hairline vertical crack was observed that extended from the top of the pier to 1 foot above channel bottom.

Monitor the exposure of the footing and partial exposure of the seal at the upstream nose of the pier, and if found to be progressing, additional measures may then be warranted.
